George Rogers Park

Lake Oswego, Oregon

Master Plan

Inventory & Analysis

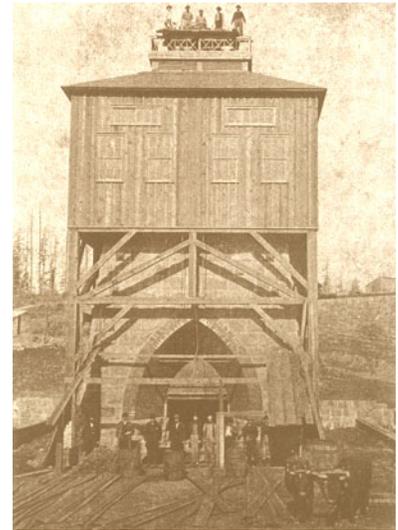
Furnace, Oswego Iron Company, under construction, 1866 (Lake Oswego Public Library)

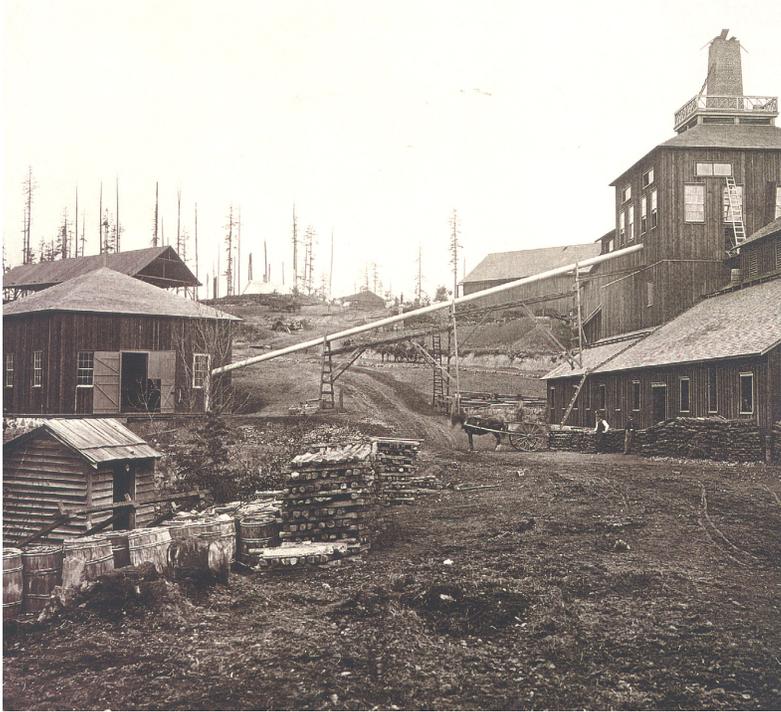
Blast-House (left) and Furnace (right) with stacks of wood for making charcoal, Carleton Watkins, photo, 1867 (Nickel 1999:131).

The furnace was 32 feet high and 34 feet square at its base. The stack tapered upward to a 26 foot square. At this point a square brick chimney rose another 50 feet. The bosh itself sat inside the furnace and was 9-1/2 feet in diameter. The pipes for the blast ran through each of the three tuyere arches. The arches also provided access for replacement of the bosh and maintenance of the tuyeres. A Roman arch window on the back side of the stack was most likely an early charging portal.

Surrounding the entire furnace was the stack frame. It fit snugly to the furnace and provided a wooden support structure for the top house. The top house was a structure that enclosed the top of the furnace and extended another 20 feet above to encase half of the chimney. The top house was four feet larger than the chimney on each side allowing for a small work area. The square, brick chimney rose another 18 feet beyond the top house and was capped with hood (Peting, Walters and Pinyerd 2001:5-6).

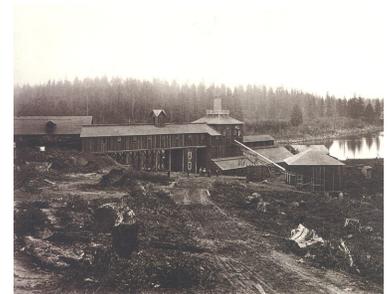
Casting building (left), Furnace (center), and Blast-House (right) at mouth of Sucker Creek, 1867, Carlton Watkins photo (Nickel 1999:127).

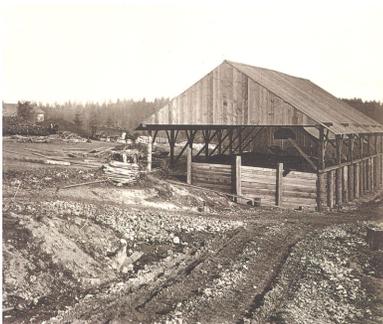
Charcoal storage building, Oregon Iron Company, 1867, Carlton Watkins photo (Nickel 1999:126).

- Furnace building, a multi-storied, wood-frame structure surrounding the furnace and chimney;
- Dwelling, a two-story building located south of the furnace possibly used as office and dwelling;
- Dwelling/river landing shelter, a small, wood building located south of the furnace on the sand spit at the mouth Sucker Creek;
- Shed, a small wood building with gable roof located on the bank of Sucker Creek;
- Blast-House, a square, wood frame building with hip roof with a long pipe connecting to the furnace; this structure stood on a stone foundation near the bank of Sucker Creek;
- Casting building, T-shaped, wood frame structure on stone foundation, located north of the furnace/smelter;
- Charcoal shed, a structure with open walls located on the hillside west of the furnace/smelter.

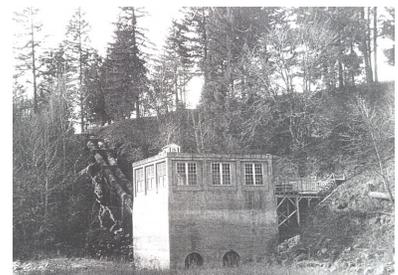
Generator Building and penstocks, Oswego Lake Water, Light & Power Company (Janet Banks Collection).

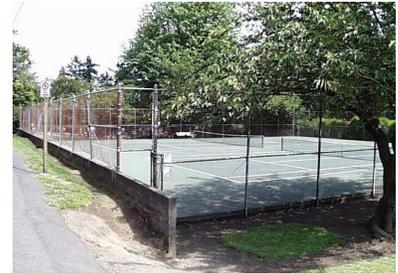
Tennis Courts, viewed from Ladd Street.

Two outdoor tennis courts are located between the athletic fields and the Children's Play Area, with frontage on Ladd Street. The courts are enclosed with chain link fencing, with north-south orientation. On the north side of the courts is a three-foot retaining wall up against Ladd Street.

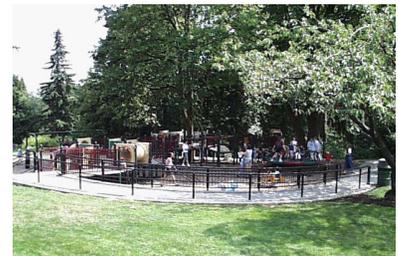
Children's playground structure, viewed from Ladd Street.

The children's playground is a popular element of the park, and is a recently renovated facility. The play structure is targeted for children eight years and younger, and includes elevated platforms, walks, slides and climbing activities. The structure is accessible for disabled play. The playground area includes a sandbox and a concrete climbing structure, both of which are well used. There are two benches located at the perimeter of the playground structure, as well as two picnic tables, one fixed-mounted, and the other moveable.

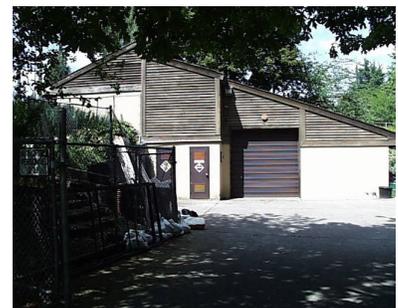
Restroom / Maintenance Facility.

The restroom/maintenance facility is a two storey structure located on the southeast side of the athletic fields adjacent to the tennis court and upper picnic shelter. The upper level, which includes men's and women's restroom facilities, a mechanical chase and a storage area, is approximately 639 s.f. The lower level, which includes the maintenance area, two

exterior storage rooms and access to the mechanical chase, is approximately 809 s.f. Total area of the building is 1,448 s.f., in a split-level design.

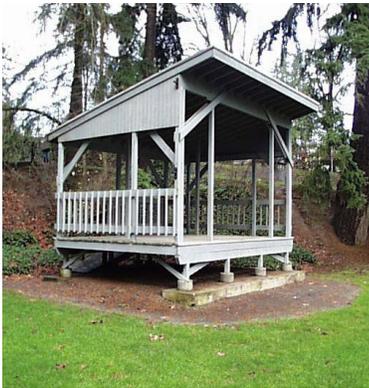
Bandstand located at edge of concert lawn.

The bandstand is a freestanding structure located in the Concert Lawn and is approximately 200 s.f. in area. The building is open on all four sides and consists of a raised platform with exposed concrete support piers, a wood-framed floor, standard wood framing support columns, and a wood-framed shed roof with asphalt shingles. The platform is accessed via a ramp on the back of the structure.

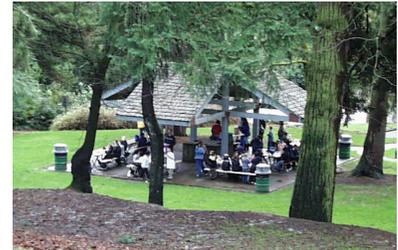
Lower picnic shelter located in concert lawn, viewed from playground terrace.

The lower picnic shelter is located in the concert lawn, in close proximity to the bandstand. It provides 720 s.f. of covered area with a capacity for approximately 75 people. The shelter is open on all sides and consists of a slab on grade, heavy timber columns and roof framing members and a cedar shake roof. The plan is based on a nine-square pattern with the roof form consisting of a series of four shed roofs radiating from a central square opening in the roof. A fixed grilling area is provided in the center of the structure.

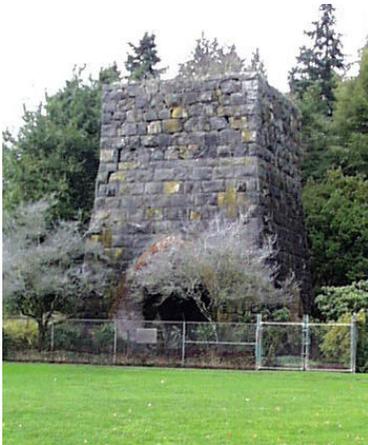
Historic smelter remnant, viewed from Memorial Gardens.

The smelter is an artifact from the park site's industrial past, with tremendous significance to the story of the City of Lake Oswego's founding as well as industry in the State of Oregon. This history is described further in the historical research heading of this report.

The smelter is currently a special project with the City of Lake Oswego, with efforts being made to assess and stabilize the condition of the structure and to evaluate the archaeological resource potential of the remnant. The smelter is located at the northern end of the Memorial Gardens, with a chainlink fence enclosure and a planted garden at its base. It is not accessible to the general public, but is a notable presence in the garden.

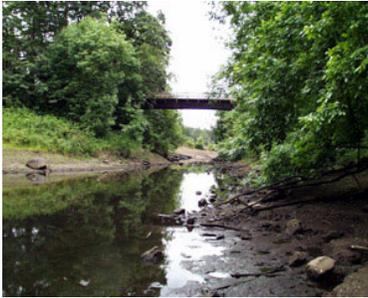
Oswego Creek looking towards Willamette River and pedestrian bridge.

Oswego Creek is part of the spillway for the dam at Lake Oswego, carrying waters from the Tualatin River to the Willamette River, as well as multiple overland stream drainages. The creek extends along the park's southern boundary, from the river back to the dam, approximately 2,000 linear feet in length. The creek is intermittent, depending on flow levels released from the lake. The creek's natural resource characteristics are described in the natural resource assessment of this document. The north side of the creek is comprised of a steeply sloping hillside, with access via a maintenance road to the Lake Corporation's concrete powerhouse building.

The creek is crossed with a pedestrian/bicycle bridge that has historically been a covered bridge for the Old River Road that paralleled the Willamette River. To the south of the bridge landing, the pathway ends in a t-intersection, with an informal pathway paralleling the creek to the west, and the paved Old River Road trail going to the east to follow the Willamette River to the south.

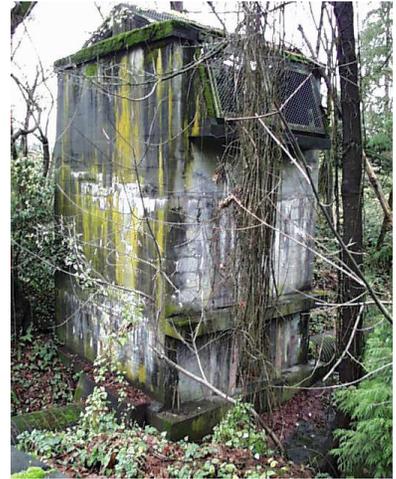
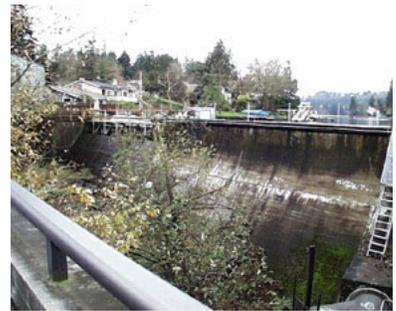
Lake Oswego dam and surge tank.

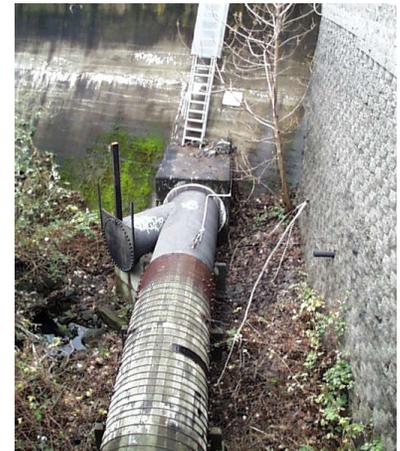
Penstock outlet at dam.

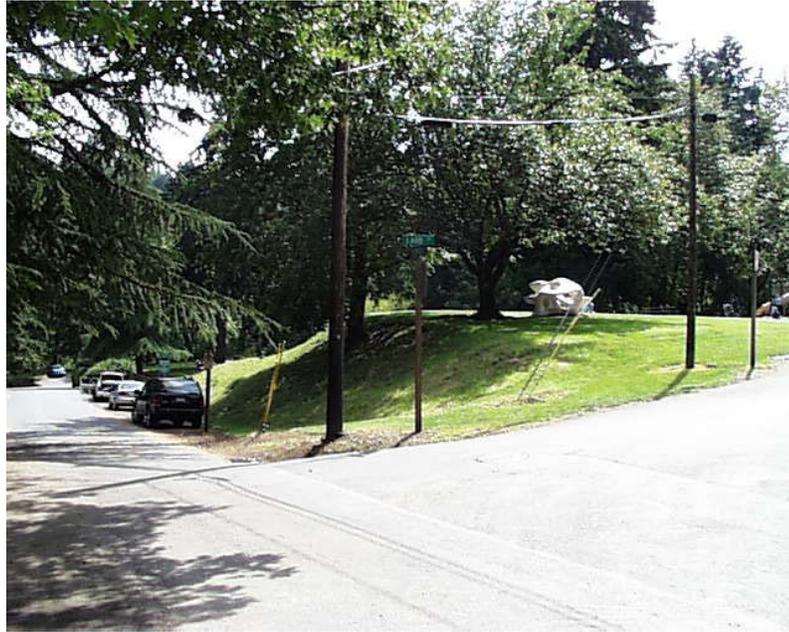
Slope at Children's Playground towards Furnace Street.

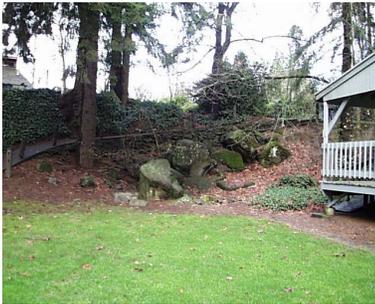
Hillside separating athletic fields from concert lawn.

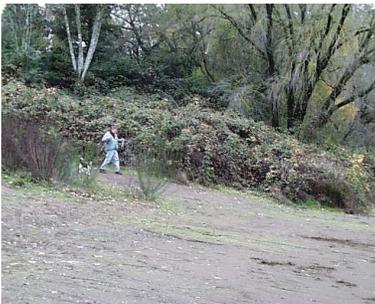
View of hillside of Memorial Garden from lower beach terrace.

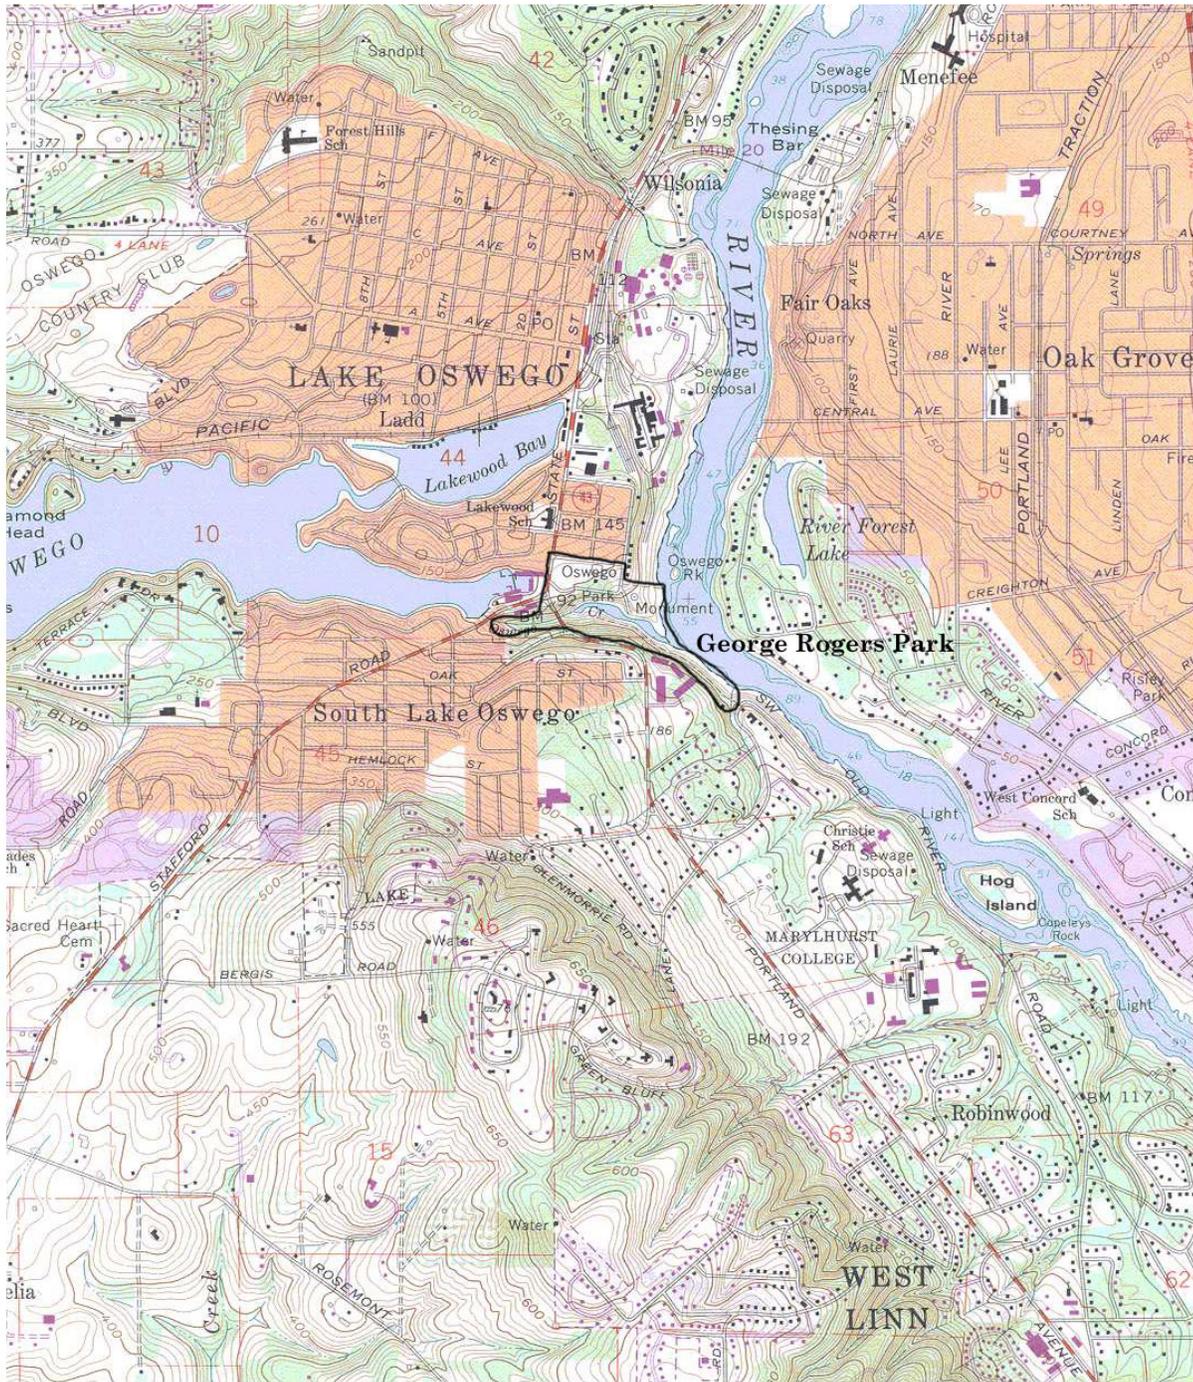
Fig. 5. Location and general topography for George Rogers Park in Lake Oswego, Oregon (USGS, Lake Oswego, Oregon quadrangle, 1961, photo-revised, 1984).

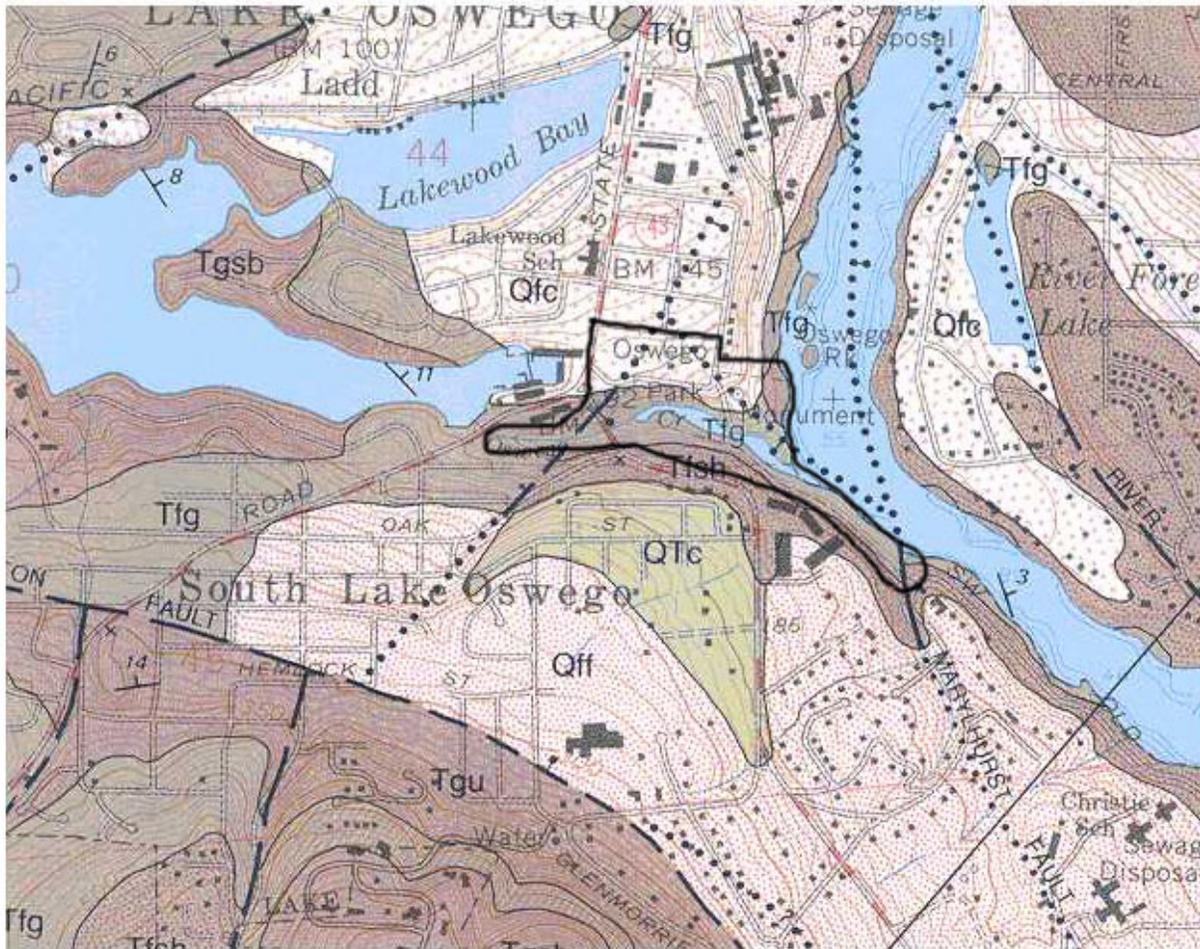
Fig. 6. Geologic Survey Map of the George Rogers Park vicinity in Lake Oswego, Oregon (USGS, Lake Oswego, Oregon Quadrangle, Clackamas, Multnomah, and Washington Counties, 1989).

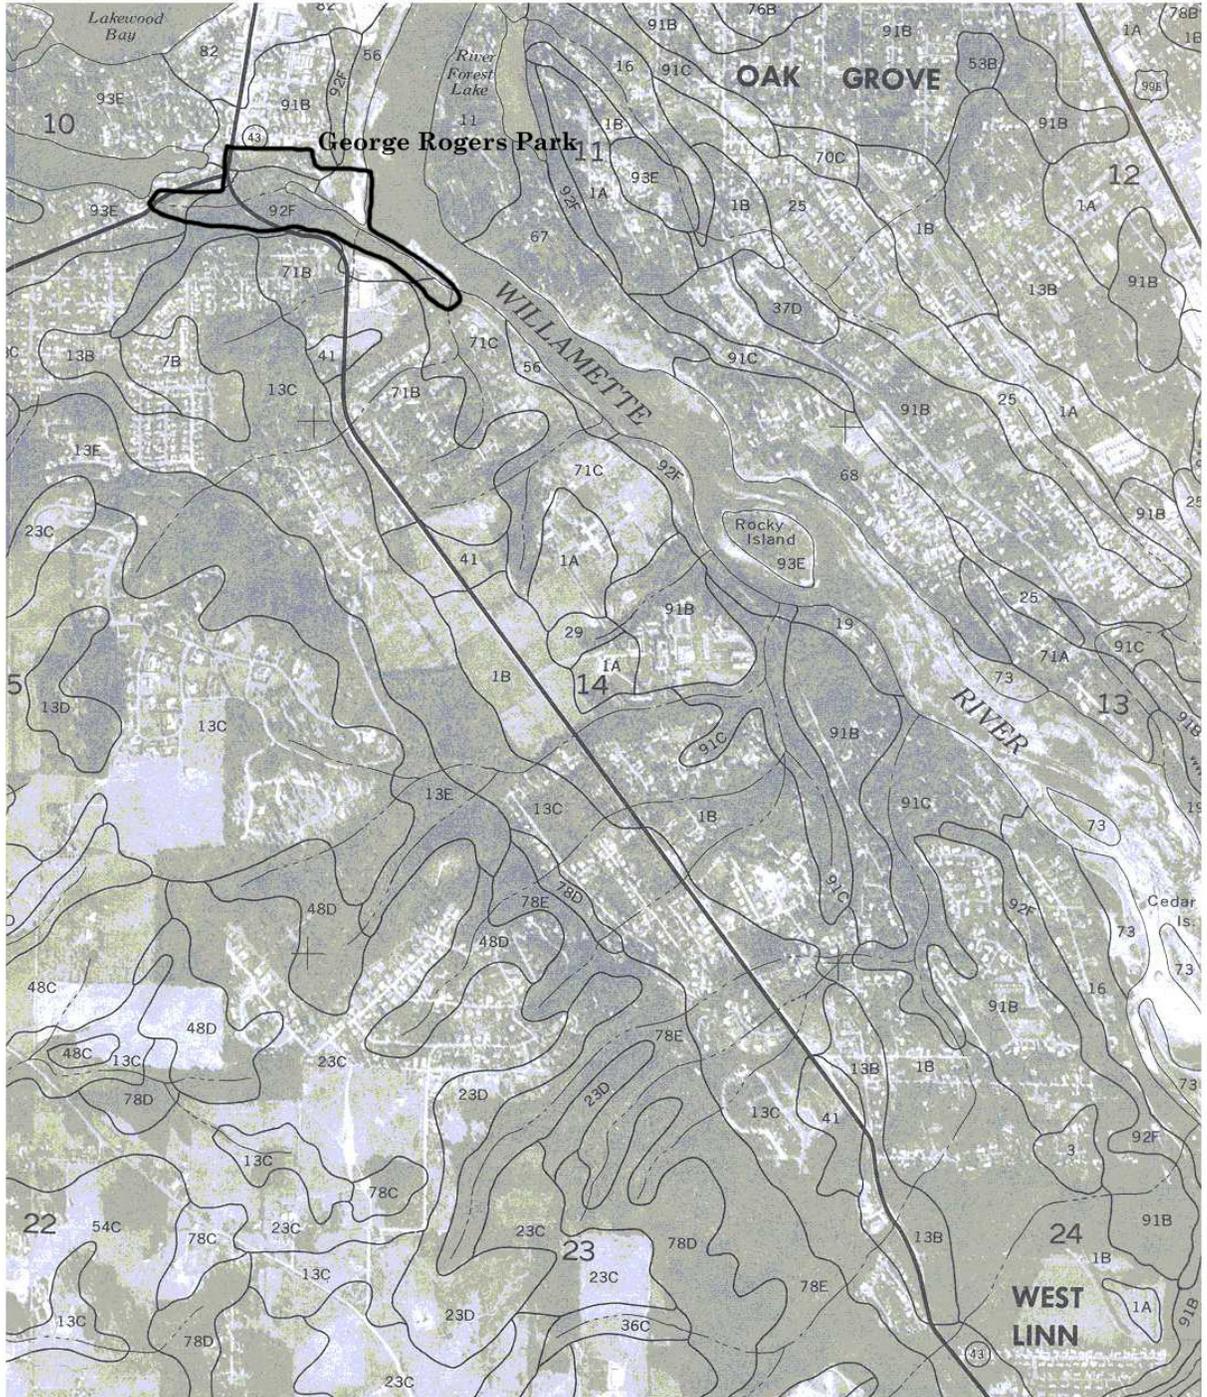
Fig. 7. Soils Series information for George Rogers Park in Lake Oswego, Oregon (Soil Survey of Clackamas County Area, Oregon, sheet 6, 1985).

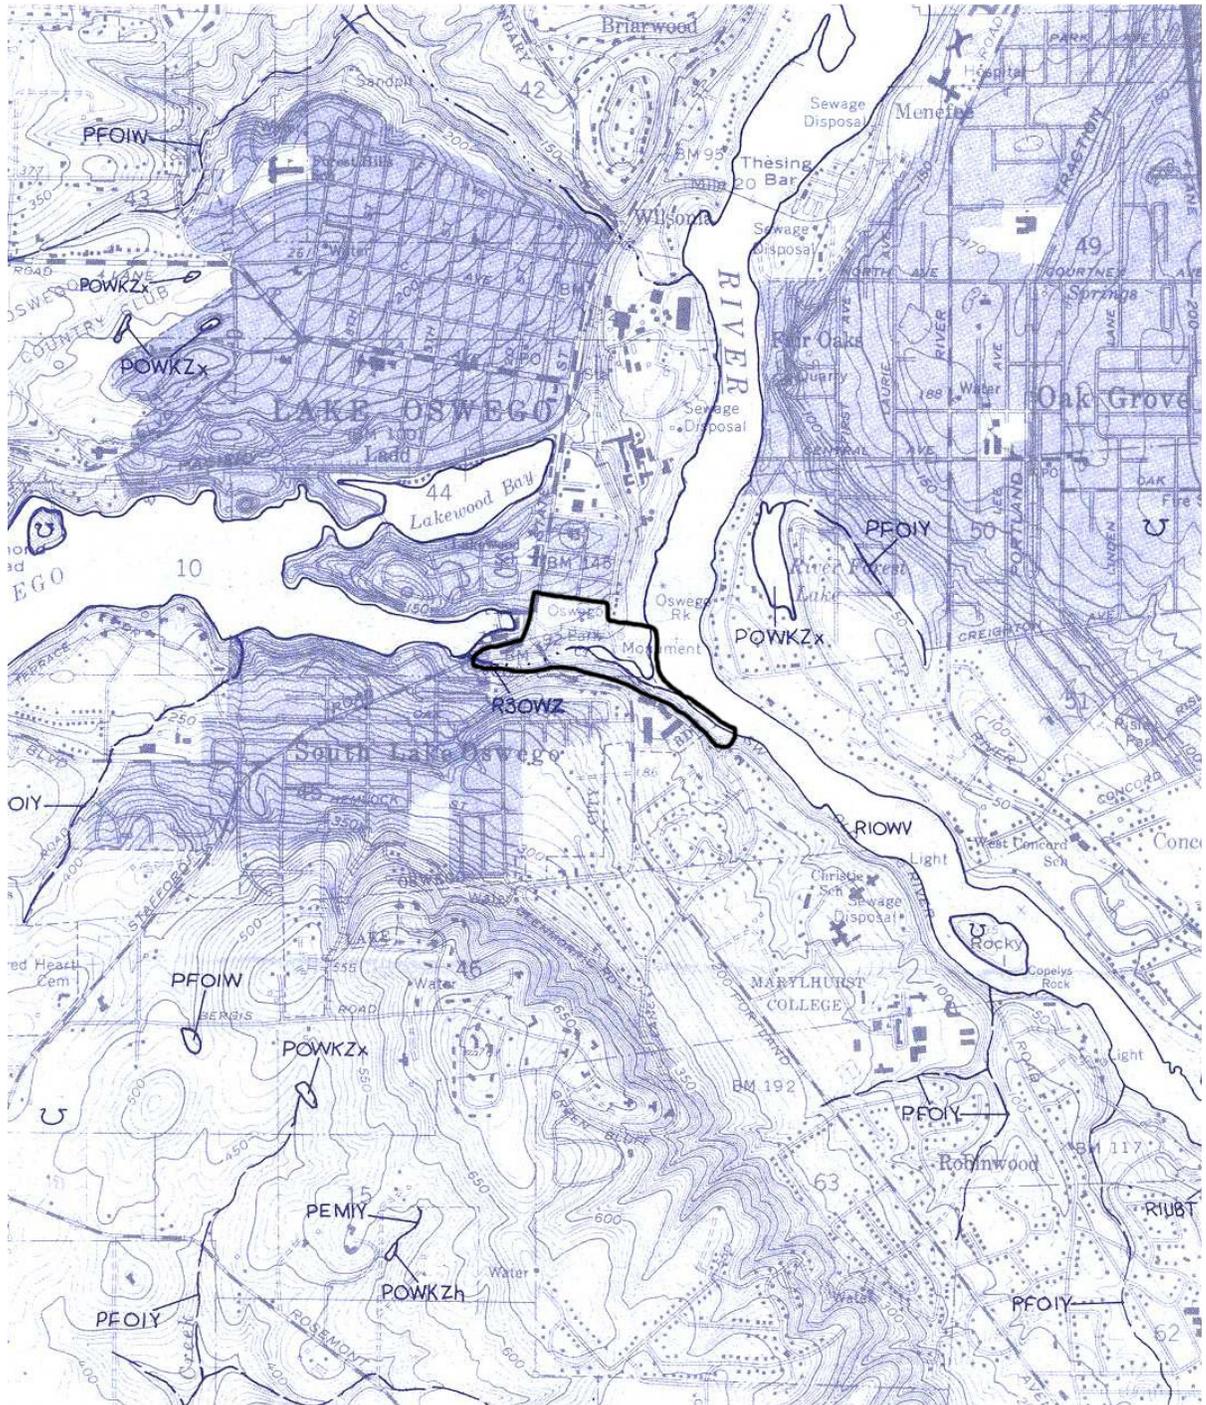
Fig. 9 National wetlands Inventory Information for GRP in Lake Oswego (USFWS, National Wetlands Inventory, Lake Oswego, Oregon Quadrangle, 1981).

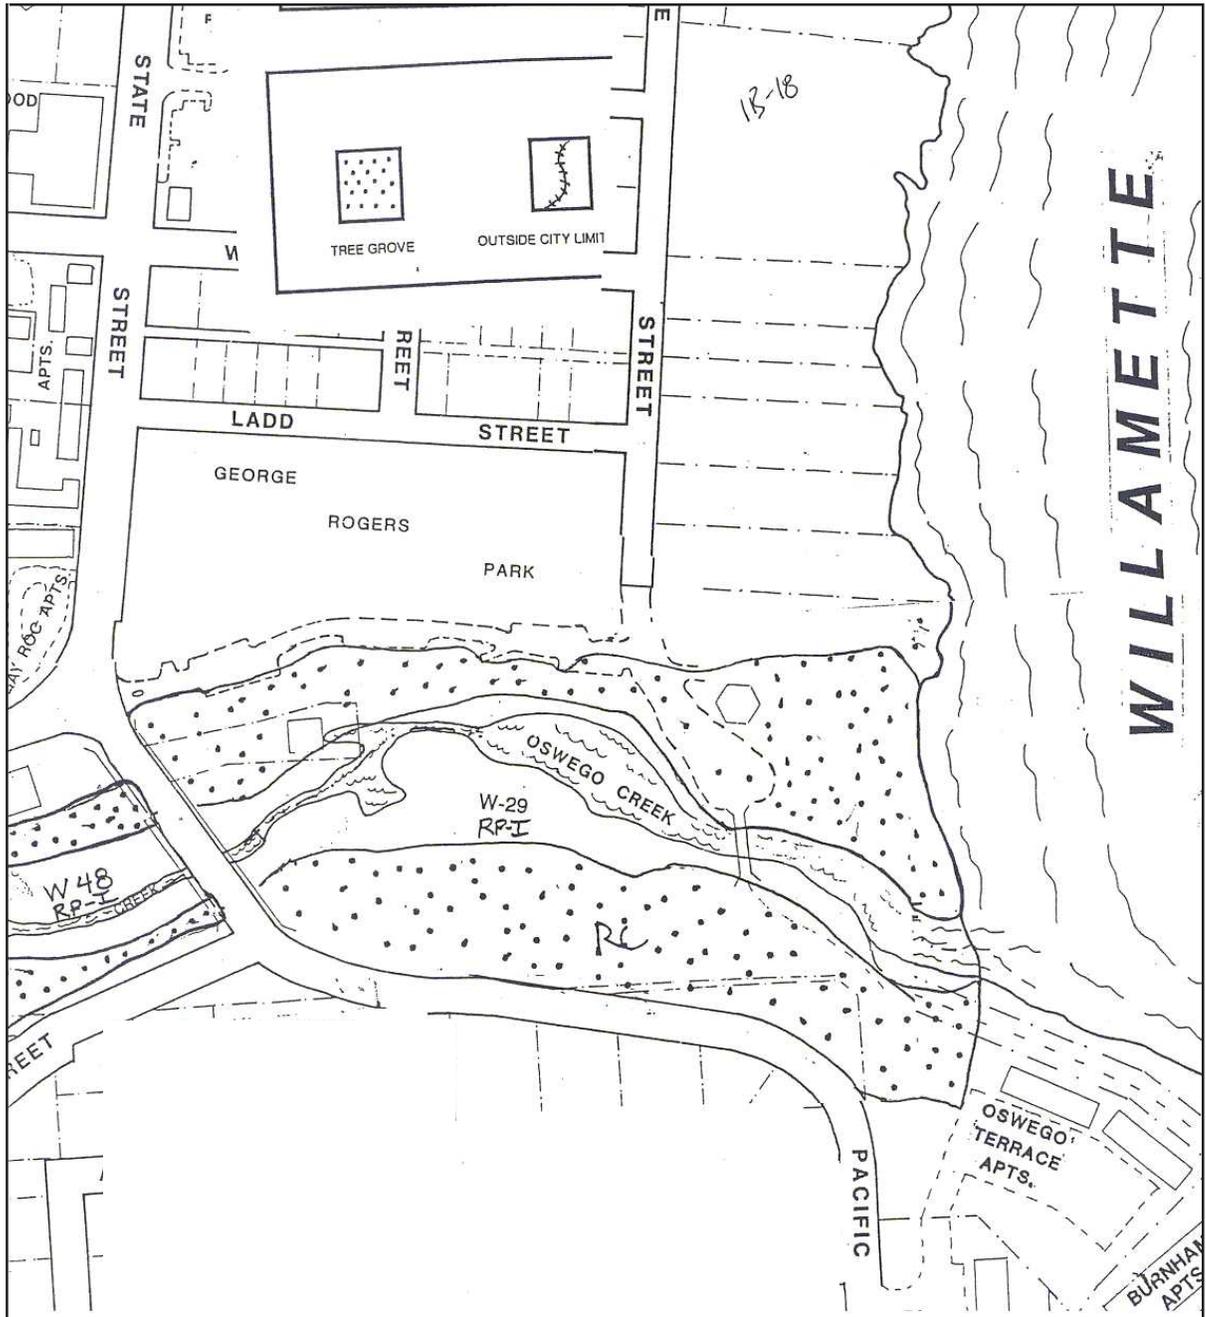
Fig. 11. Natural Resource Inventory Information for George Rogers Park in Lake Oswego, Oregon (City of Lake Oswego 1994/95 Natural Resource Inventory Individual Property Maps).

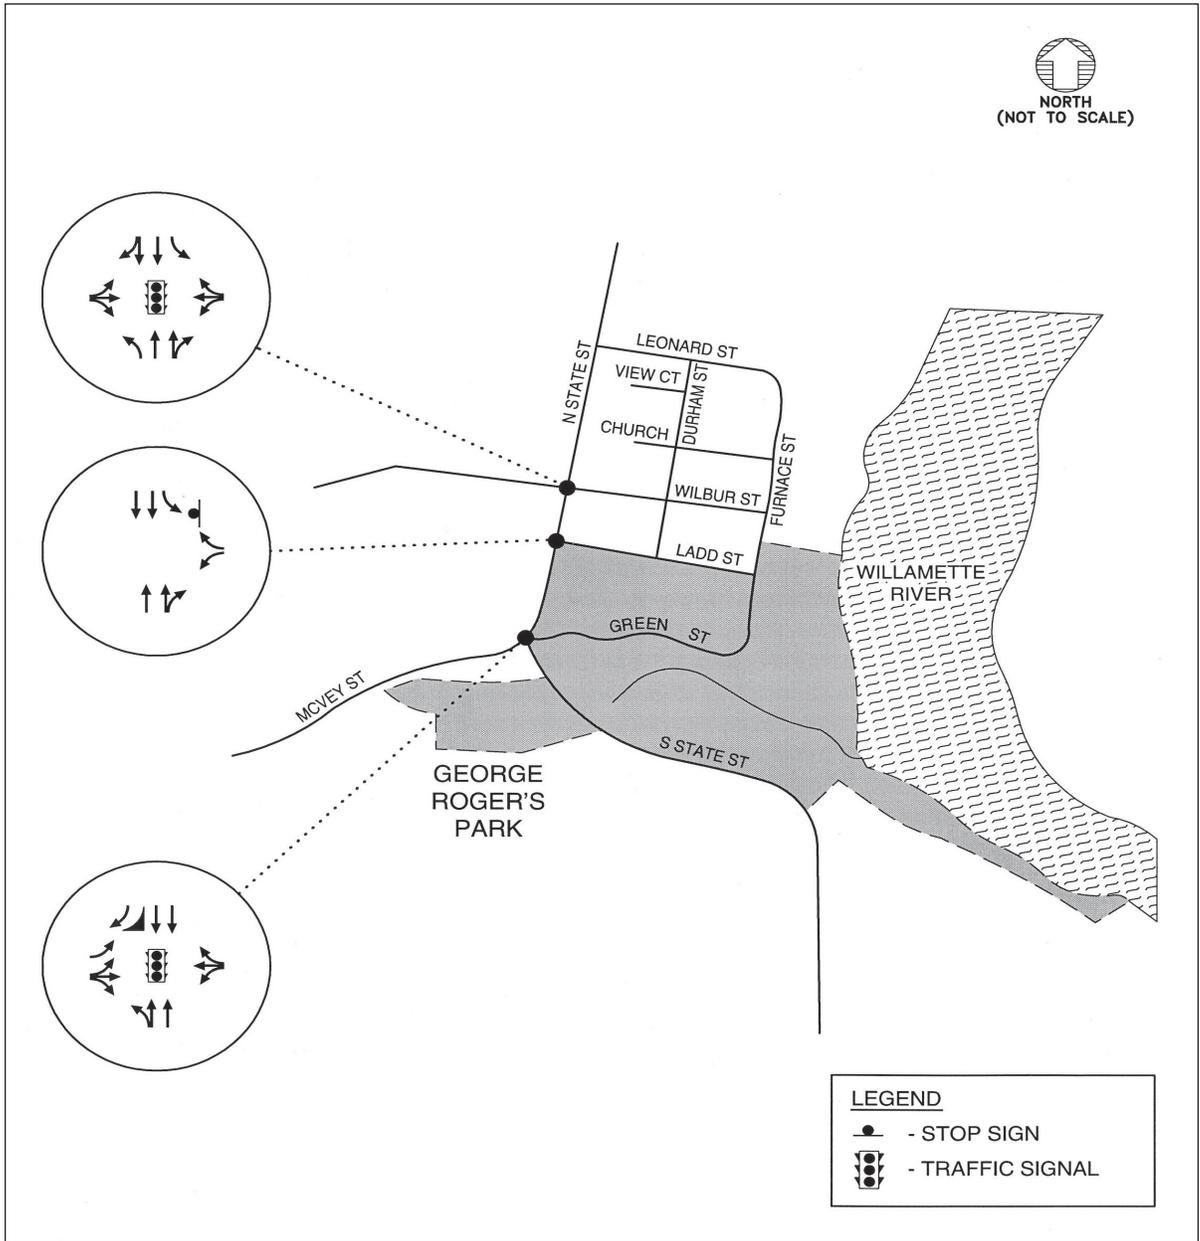
Fig. 13. Existing Lane Configurations and Traffic Control Devices.

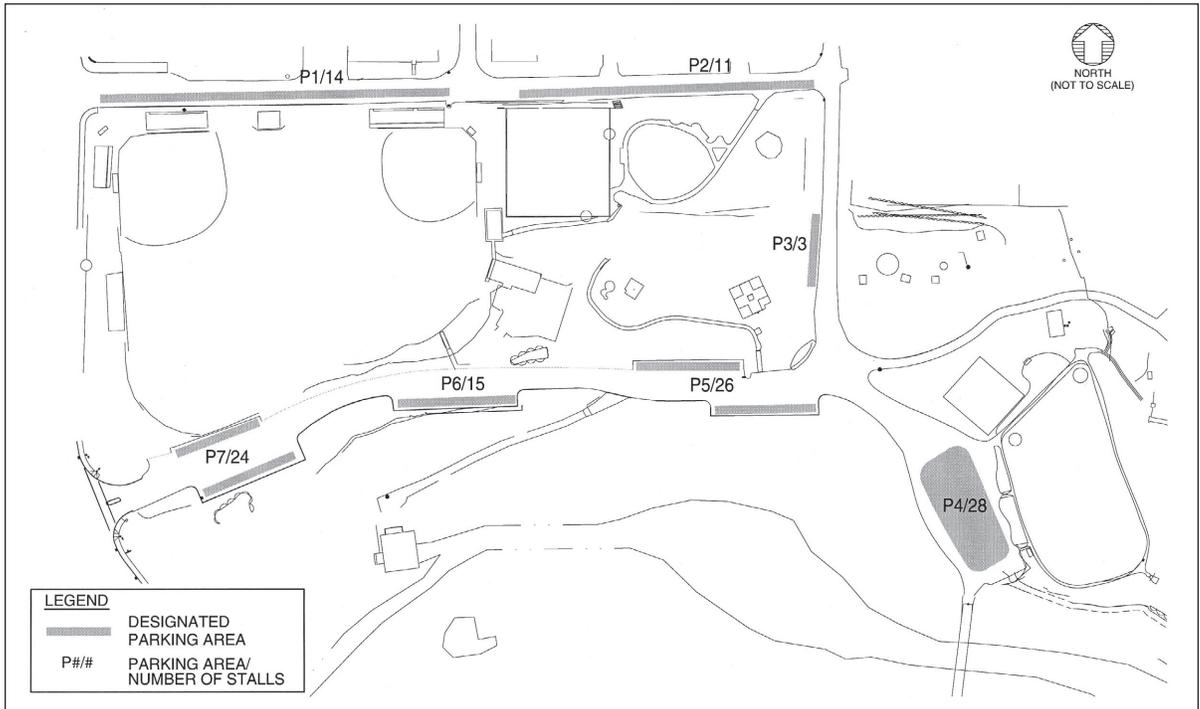
Fig. 14. Parking Locations in George Rogers Park, Lake Oswego, Oregon.

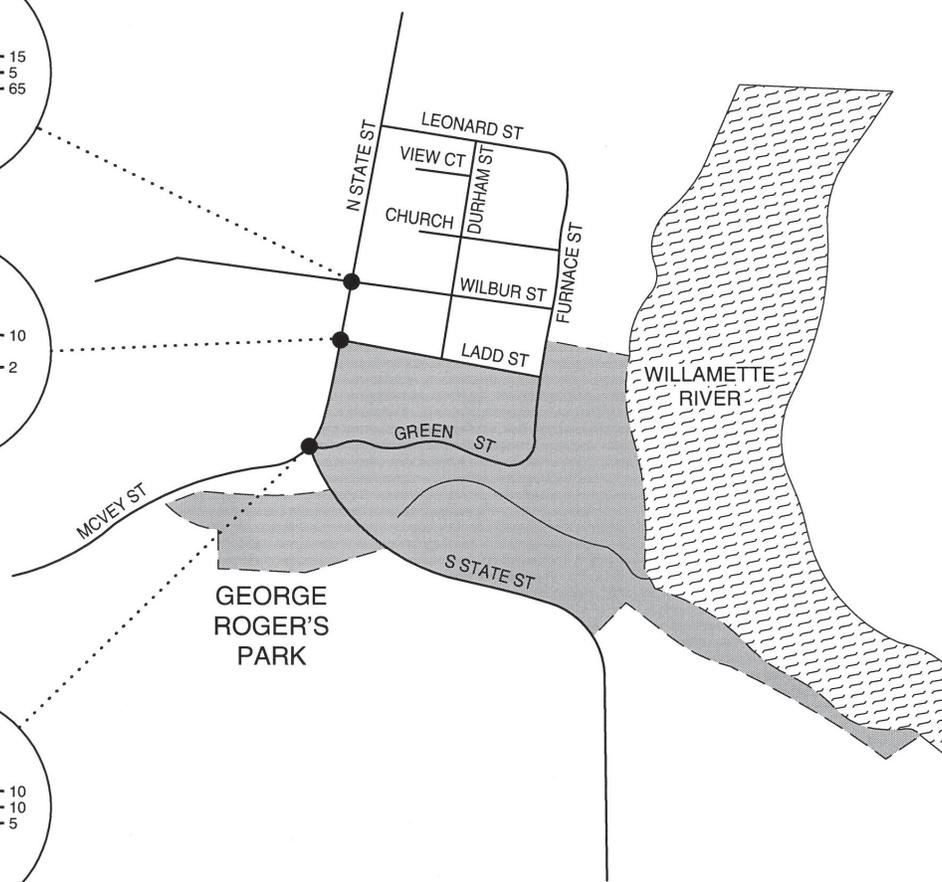
Fig. 15. Existing Traffic Conditions Weekday PM Peak Period, December 2001.

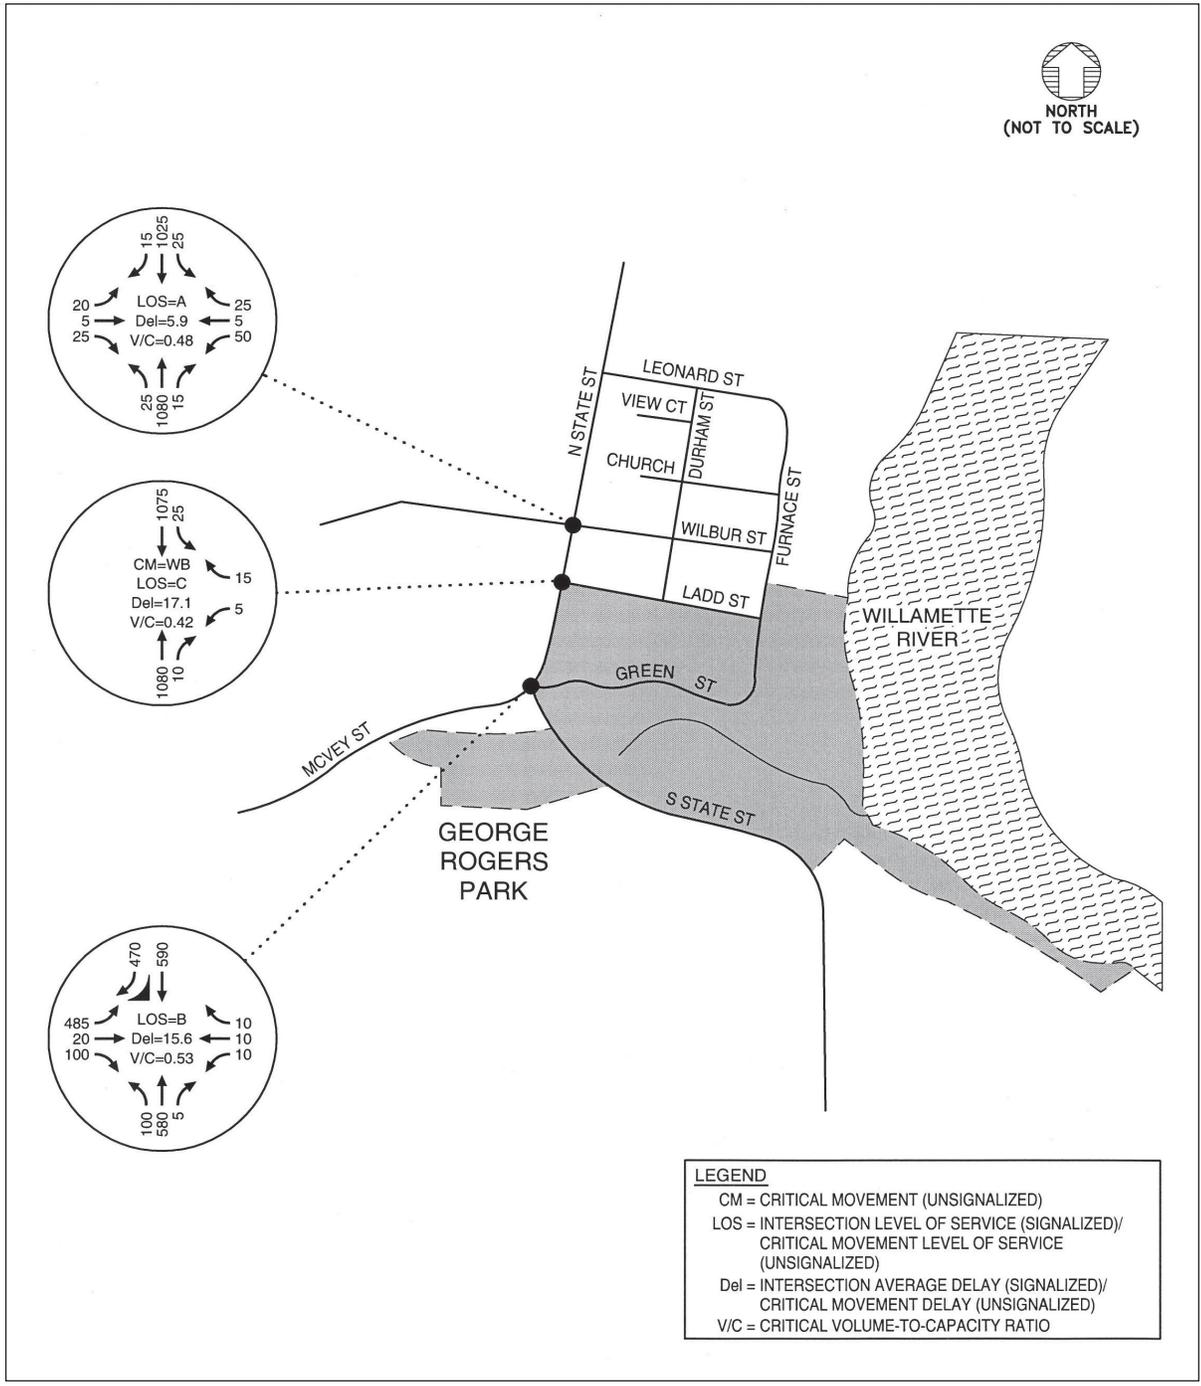
Fig. 17. Existing Traffic Conditions Saturday Mid-day Peak Period, December 2001.

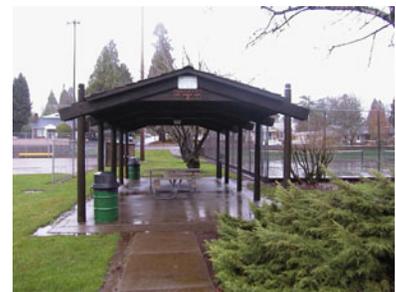
Upper Picnic Shelter

The upper picnic shelter is located on the East side of the playing fields adjacent to the tennis court and the restroom/maintenance building. It provides approximately 612 s.f. of covered area. The shelter consists of a slab on grade, heavy timber columns and roof framing members and a gable cedar shake roof. Amenities offered at the shelter include water and electrical service.

- The underside of the roof deck should be cleaned.
- The building signage should be cleaned.
- Finish surfaces are in need of refinishing.
- Lighting is limited to one ceiling mounted light fixture.
- The roof leaks and the cedar shakes show signs of age.
- The building paper between the skip sheathing and the cedar shakes has deteriorated and should be replaced when the structure is reroofed.
- Consideration should be given to providing either a permanent grill pit or a designated area for grilling around the perimeter of the structure. Finish surfaces are in need of refinishing.

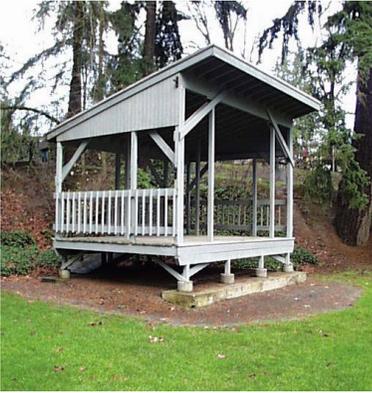
Bandstand

The bandstand is a freestanding structure located in the Memorial Garden and is approximately 200 s.f. in area. The building is open on all four sides and consists of a raised platform with exposed concrete support piers, a wood framed floor, standard wood framing support columns and a wood framed shed roof with asphalt shingles. The platform is accessed via a ramp on the back of the structure.

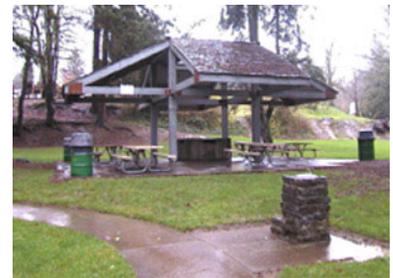
Lower Picnic Shelter

- The concrete slab is out of plane at two locations.
- There is no direct connection with the slab at the picnic shelter and the adjacent concrete path. Access from the path to the picnic shelter crosses dirt and may be difficult to negotiate for someone with a disability.
- Spacer boards are missing between the concrete slabs. The joint width is approximately 1", from edge of concrete to edge of concrete. The disparity in alignment between adjacent slabs is exacerbated by the increased joint width.
- Dry rot/infestation was observed in 3 of the 4 column bases.
- The cedar shakes are showing signs of age.
- A hose bib indicated on the Construction Documents was not found on site.
- The split face CMU half height walls indicated on the Construction Documents do not exist on site.
